Ostrander Road Bypass Bridge Replacement Project

Completed September 12, 2011

Summary

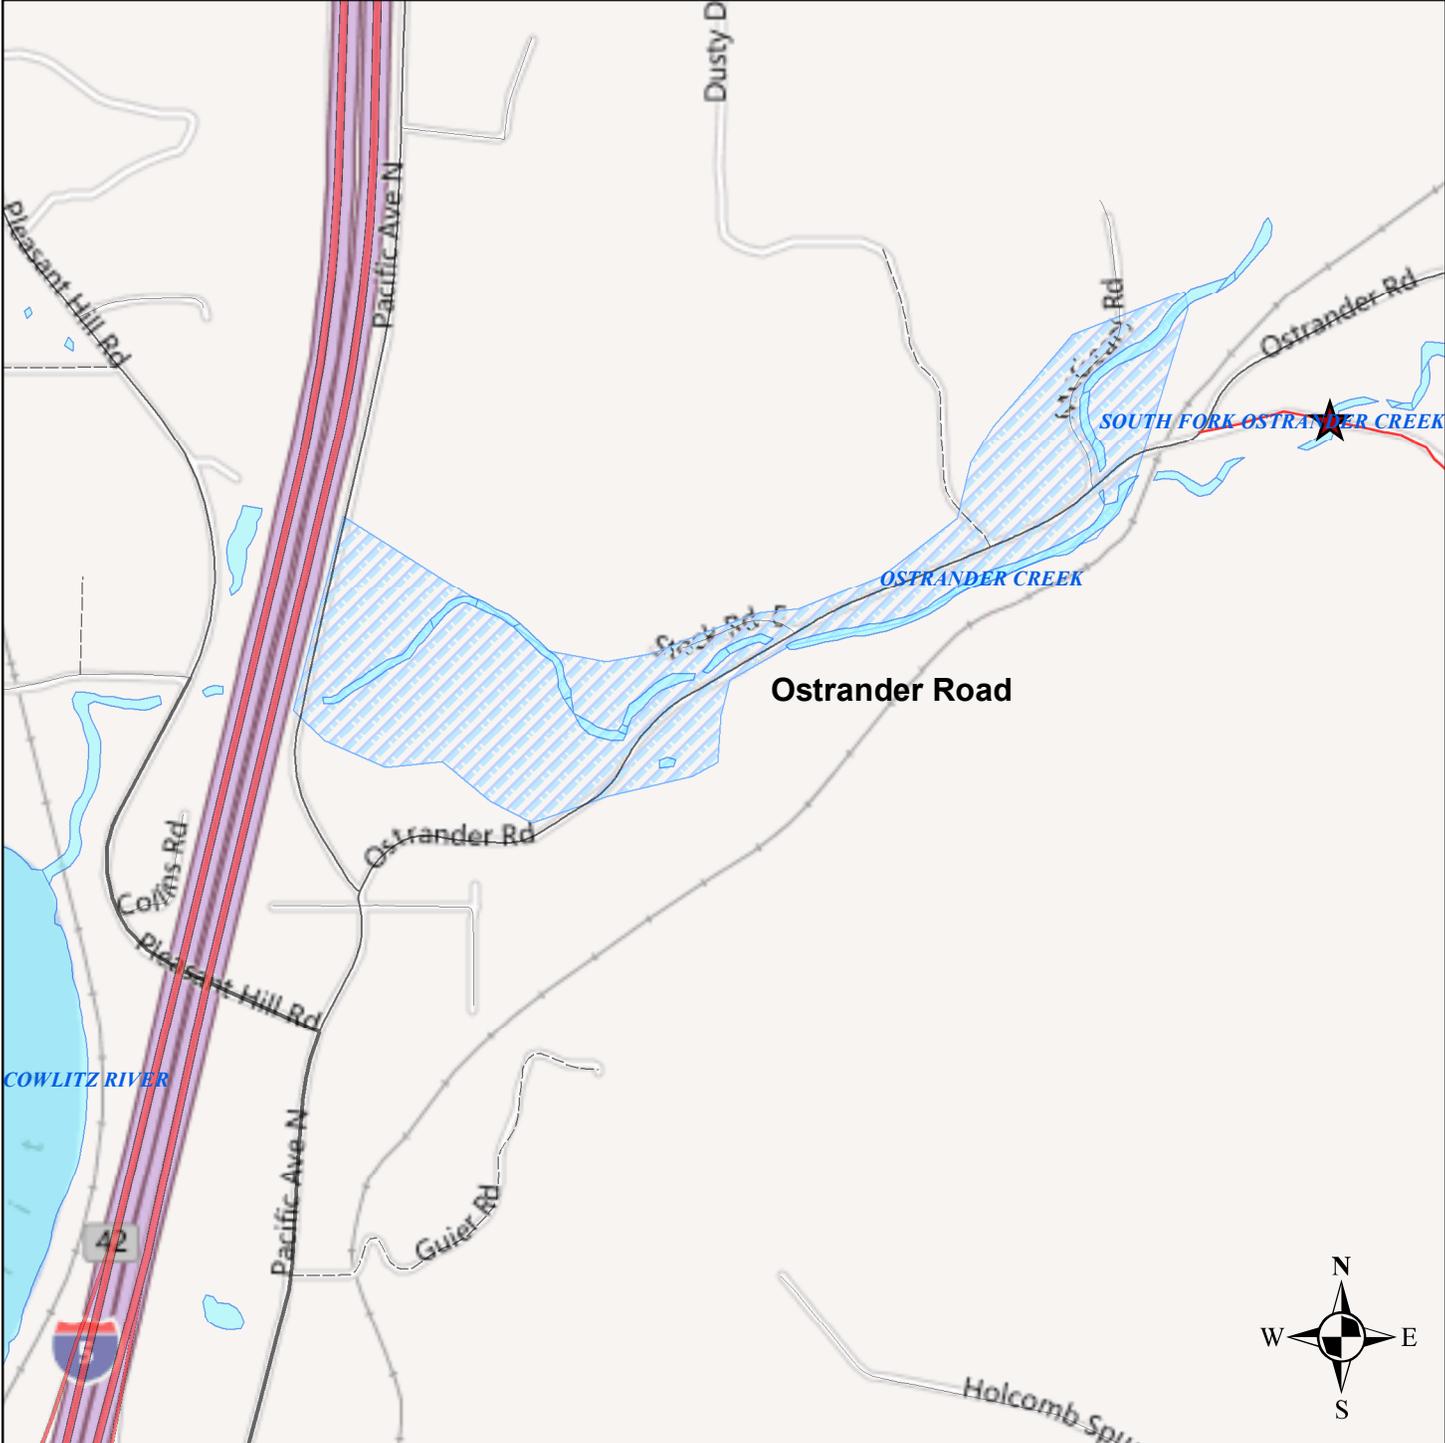
Figure 1: Illustration of the commonly flooded area, bridge replacement location and bypass road connection to Holcomb Road to the south.

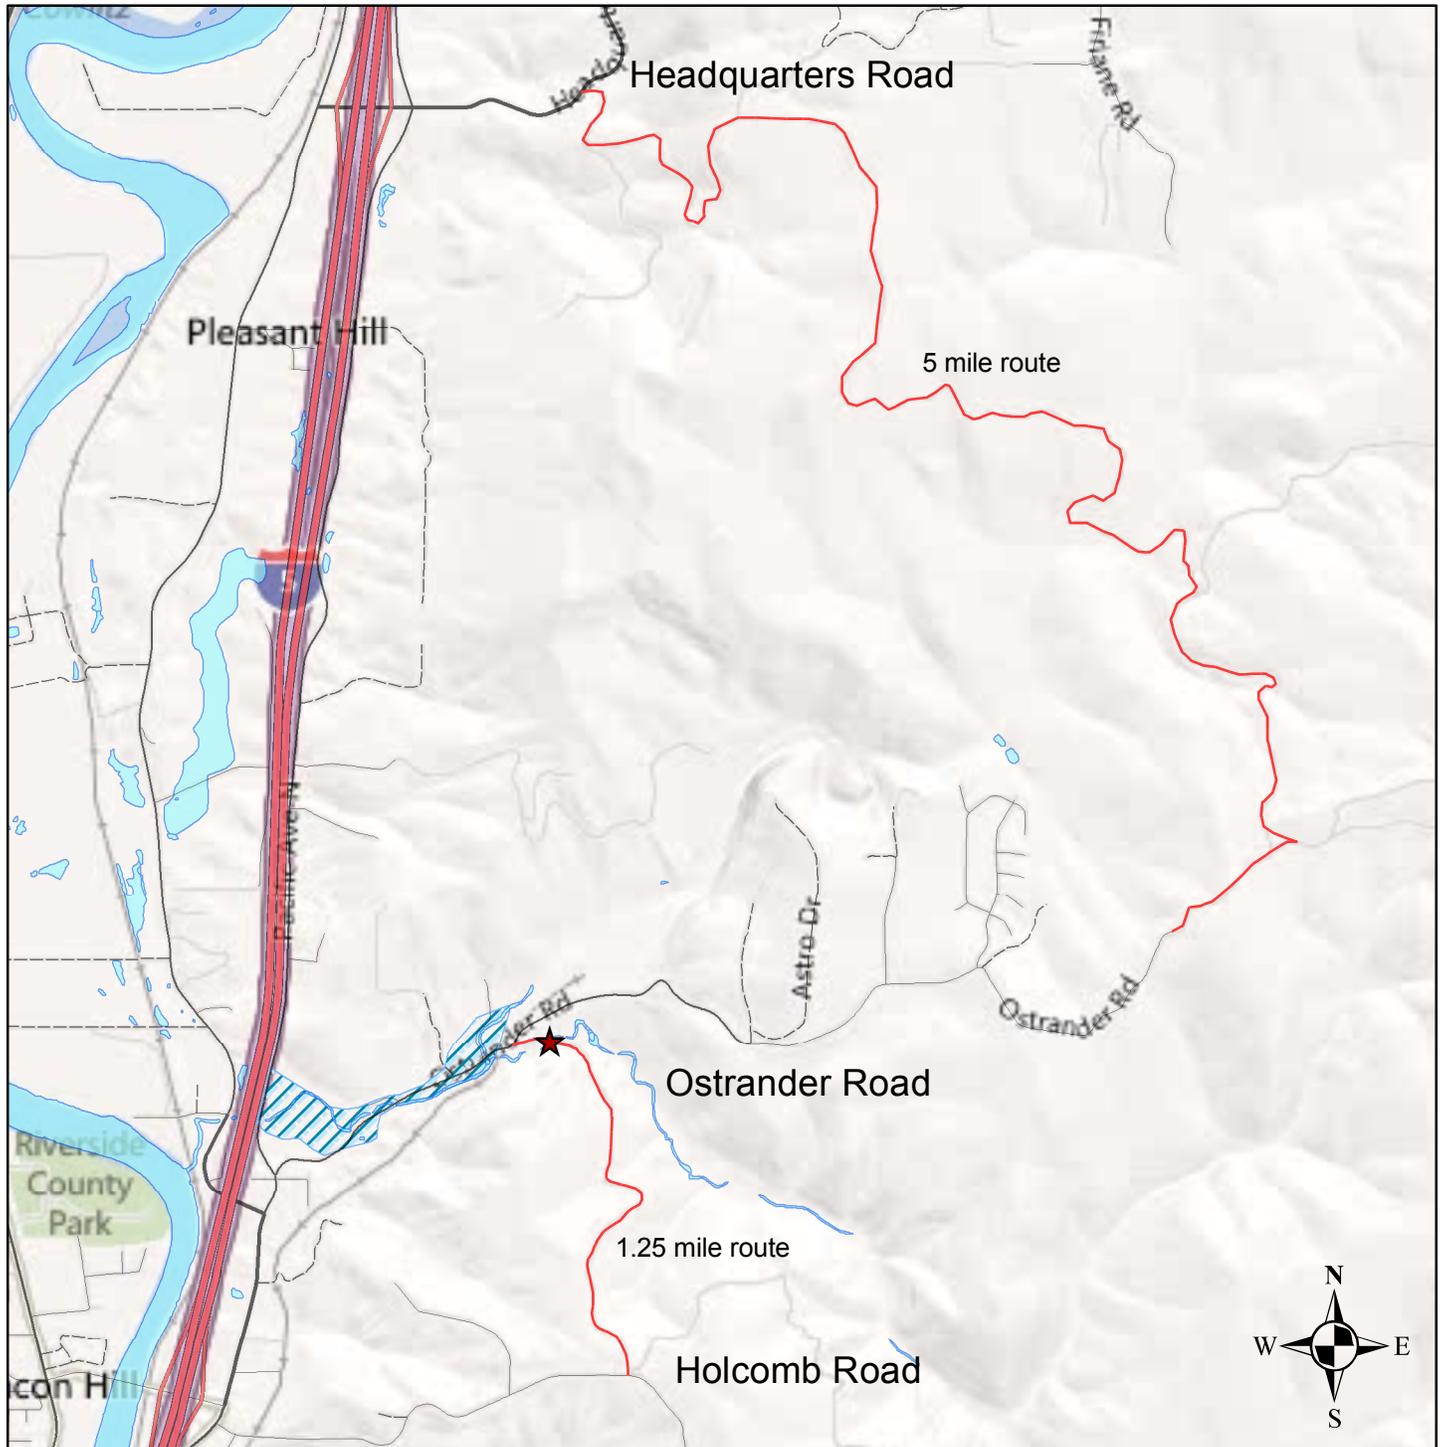
Figure 2: Illustration of the two routes used by Ostrander Road residents for emergency access. The route to the North was used during 2009 flooding events and resulted in lost individuals, motor vehicles stuck in mud and snow and hassle to private landowners.

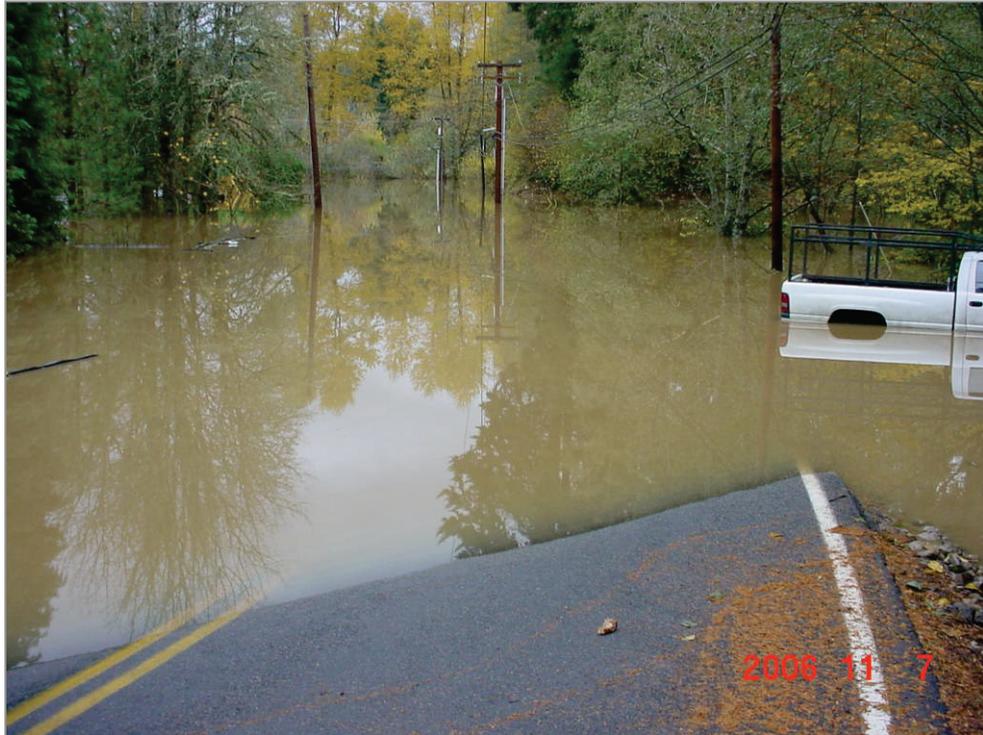
Photo 1: Ostrander Creek flooding Ostrander Road. Note turbidity and depth of water.11/07/2006.

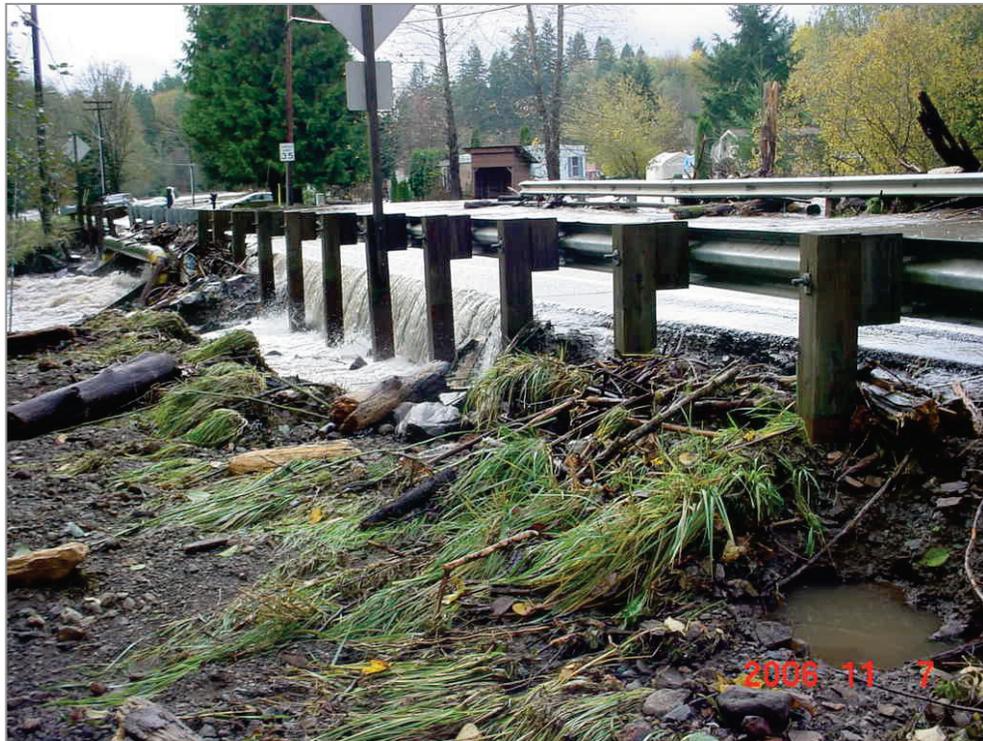
Photo 2: Ostrander Creek flooding across Ostrander Road at culvert crossing. 11/07/2006.

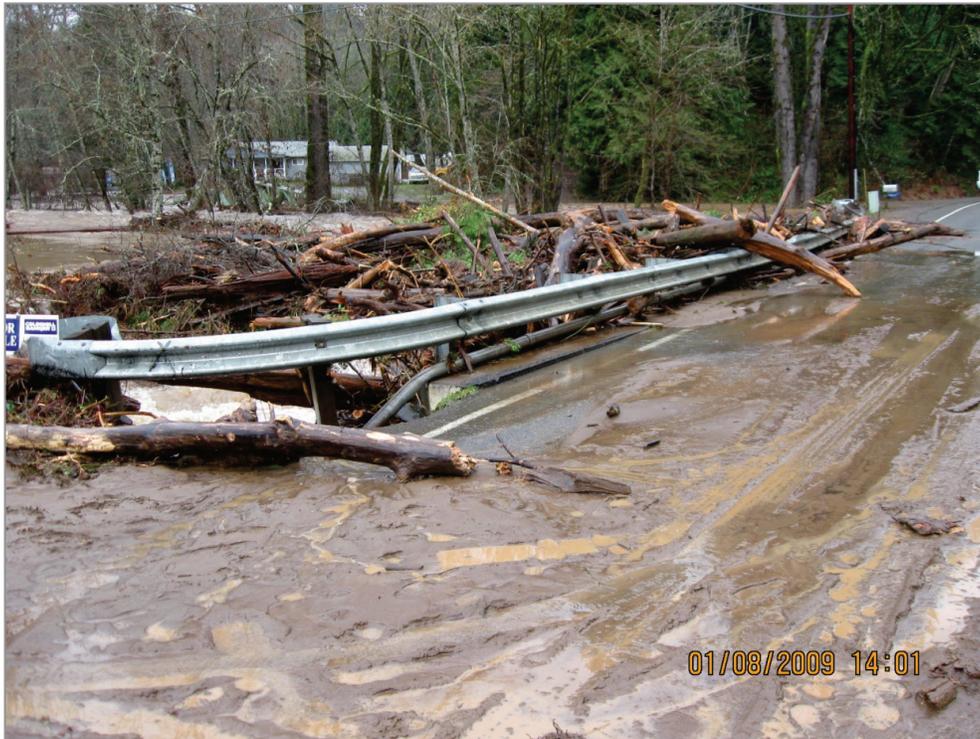
Photo 3: Flood damage and mud immediately following flood event. 01/09/2009.

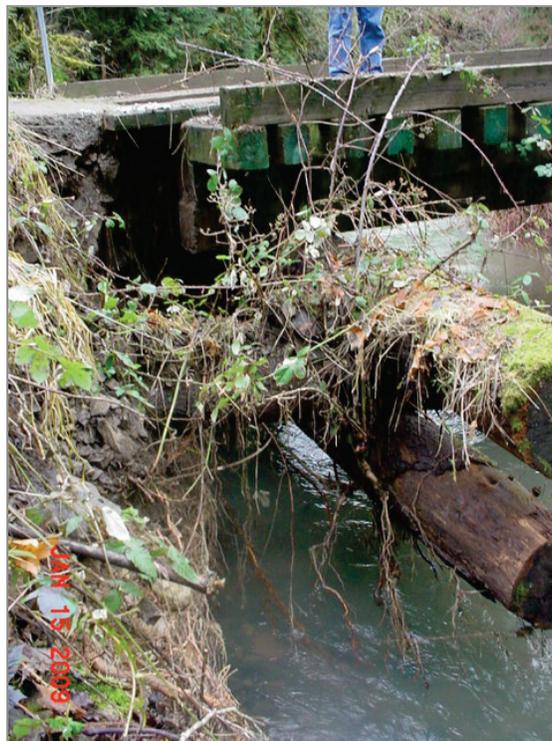
As a result of not moving forward with the realignment project, use of the existing Ostrander Road bypass route was continued. Even though the timber stringer bridge was not part of the County's bridge inventory, regular inspections were completed by County staff to ensure safety for the public during flood events. Recently, one such inspection revealed that the timber stringers and log abutments were rotting and the bridge was no longer sufficient to carry bypass traffic or any other traffic. The bridge was closed and access was blocked.

Photo 4: Following the 2009 floods the Ostrander Road Bypass bridge was declared unsafe. 01/15/2009.

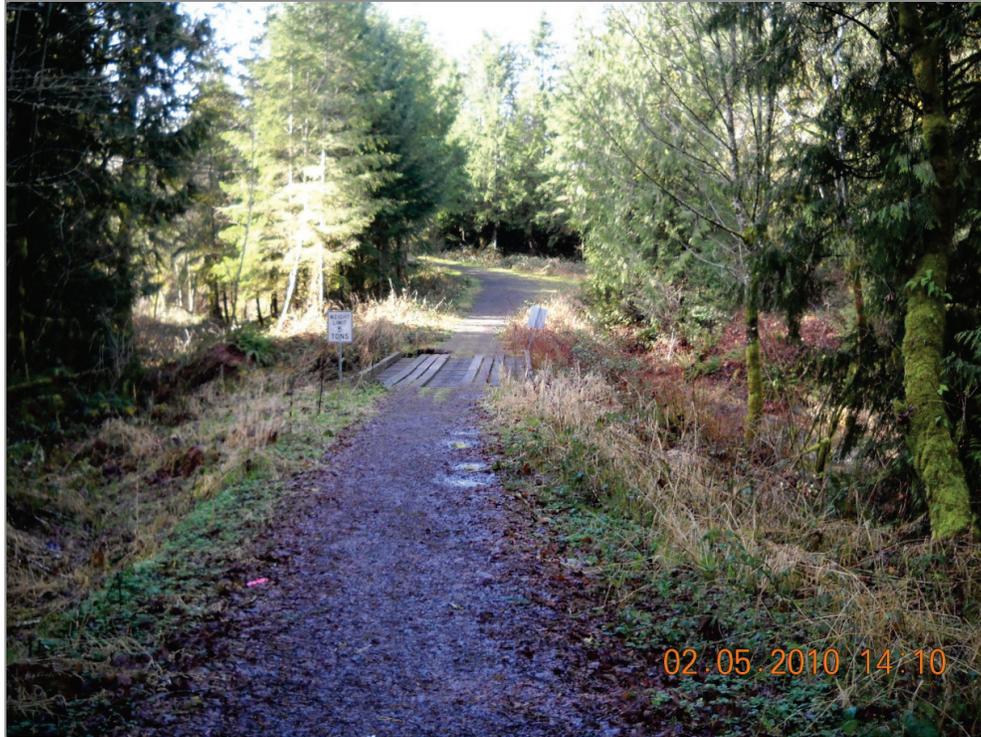
Photo 5: East bridge approach pre-project. 02/05/2010.

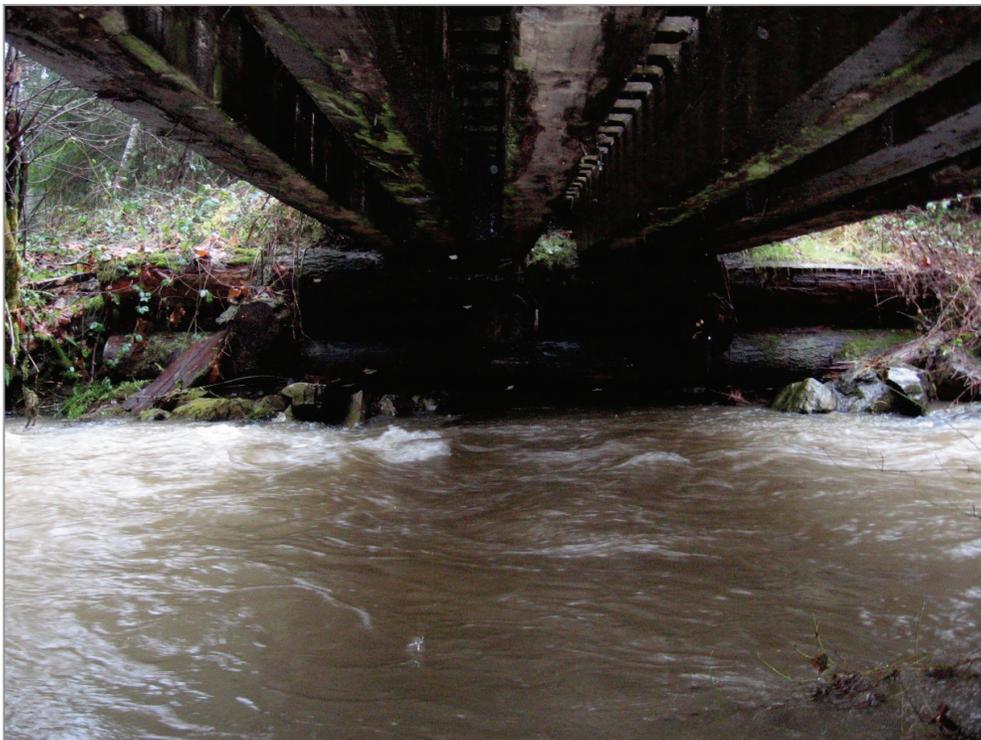
Photo 6: Bridge inspectors took this photo of deteriorated original treated timber structure. 01/06/2009.

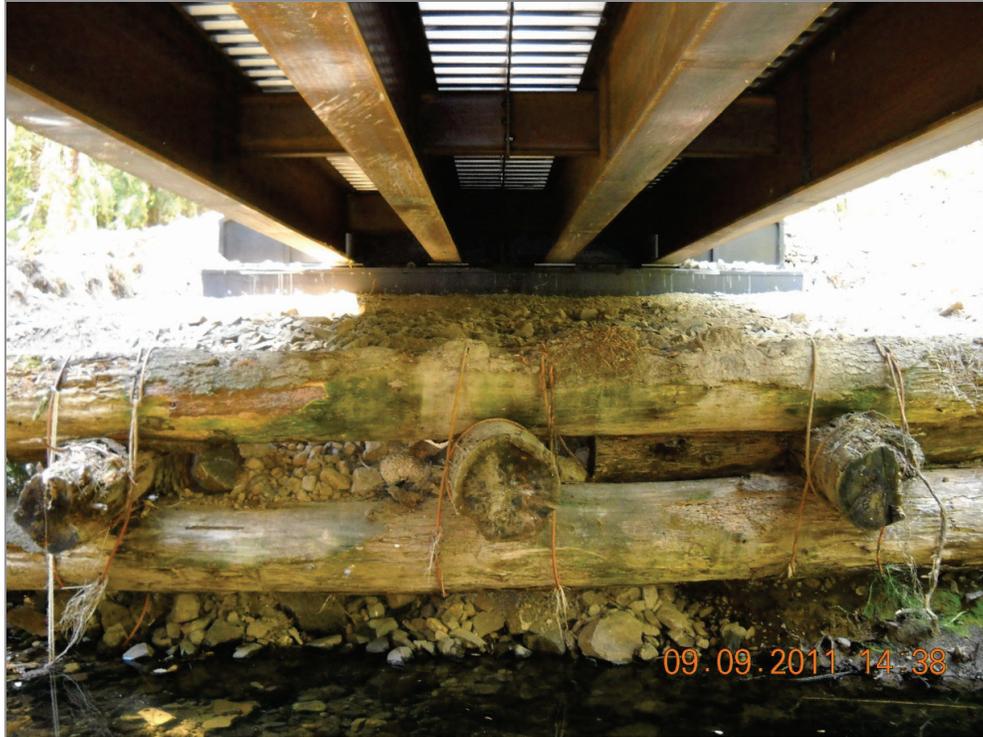
Photo 7: The old bridge abutments were left in place, which minimized impacts to the streambed. 09/09/2011.

Once the original bridge was removed, excavation for the abutments was completed. The timber abutments of the timber log bridge were left in place to minimize disturbance to the stream. The abutments that were placed consisted of hollow steel forms, called "Supersills" (Roscoe Bridge proprietary item), that were filled with concrete. When the concrete cured, the superstructure halves were placed on the abutments, bolted to the abutment, and then bolted together. Once the structure was in place, large rock and gravel were placed to complete the approaches to the bridge. The deck of the bridge was then filled with gravel for a driving surface.

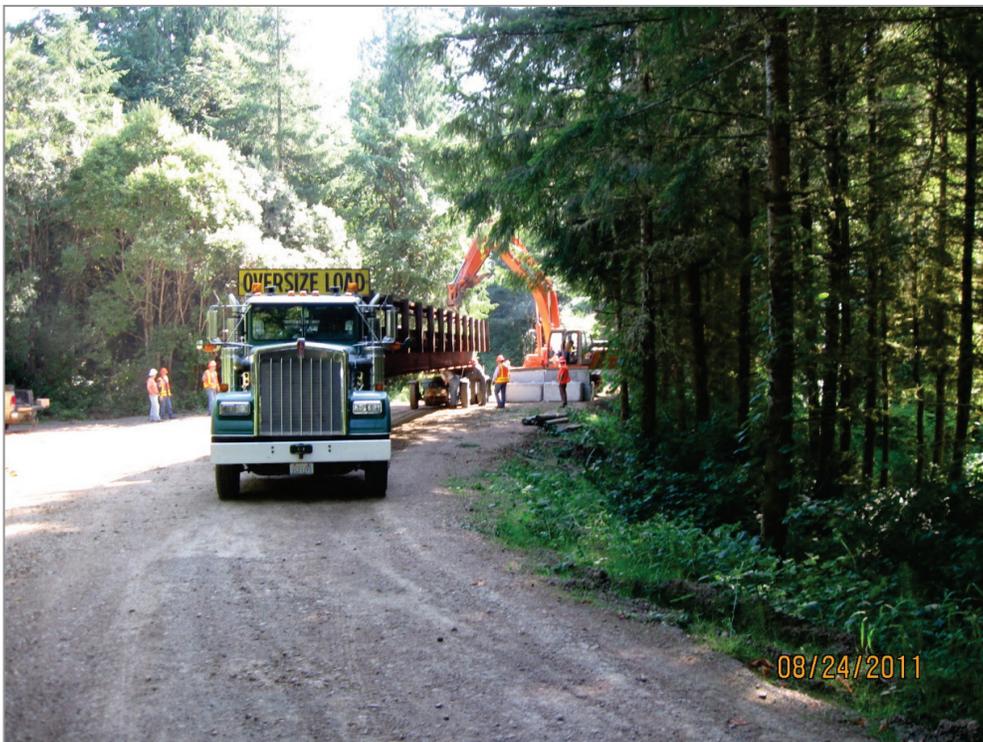
Photo 8: Heavy Hauling delivered the bridge halves to the project site. 08/24/2011.

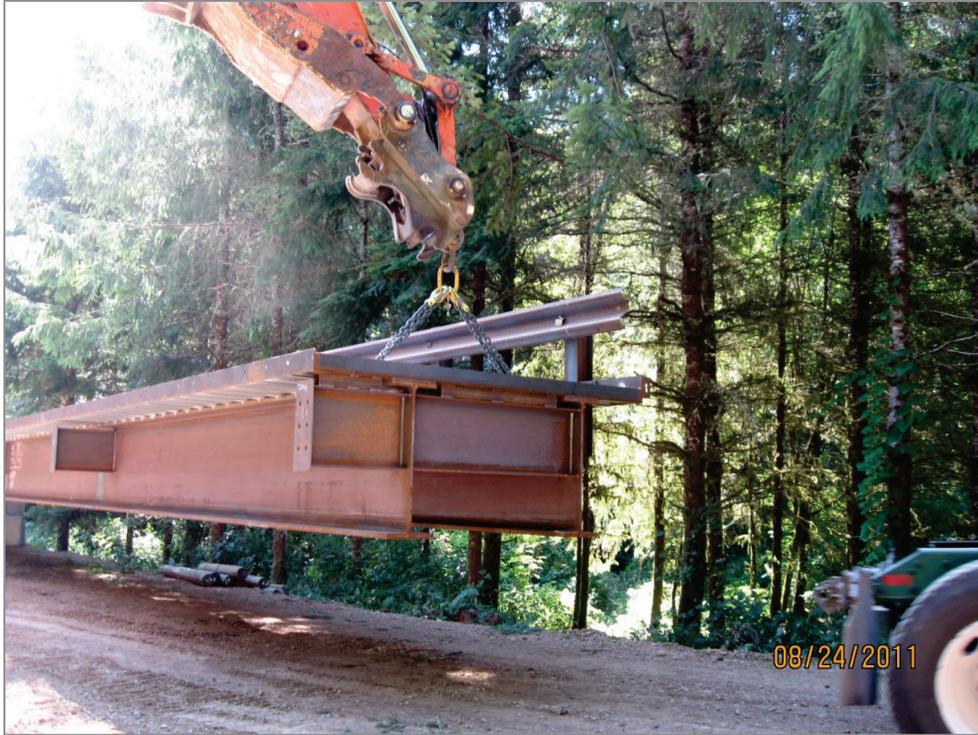
Photo 9: County crews coordinated to lift and set the bridge from the trucks. 08/24/2011.

The modular bridge installation included placement of two new abutments and two superstructure halves. Two large excavators were rented and one County loader was used for the installation. The loader and one of the excavators were used to lift and push the 44,000 pound superstructure halves across the existing timber bridge structure and creek. Round timbers were placed on the old bridge deck to allow the leading end of the modular bridge to roll. The second excavator was positioned on the other side of the stream to pick up the leading end of the structure when it came within reach. The half structure was then set downstream of the existing bridge and the second half structure was moved across and stacked on the first structure. The original bridge was then cut with chain saws and large segments were removed in their entirety. Ostrander Creek was undisturbed during the removal process.

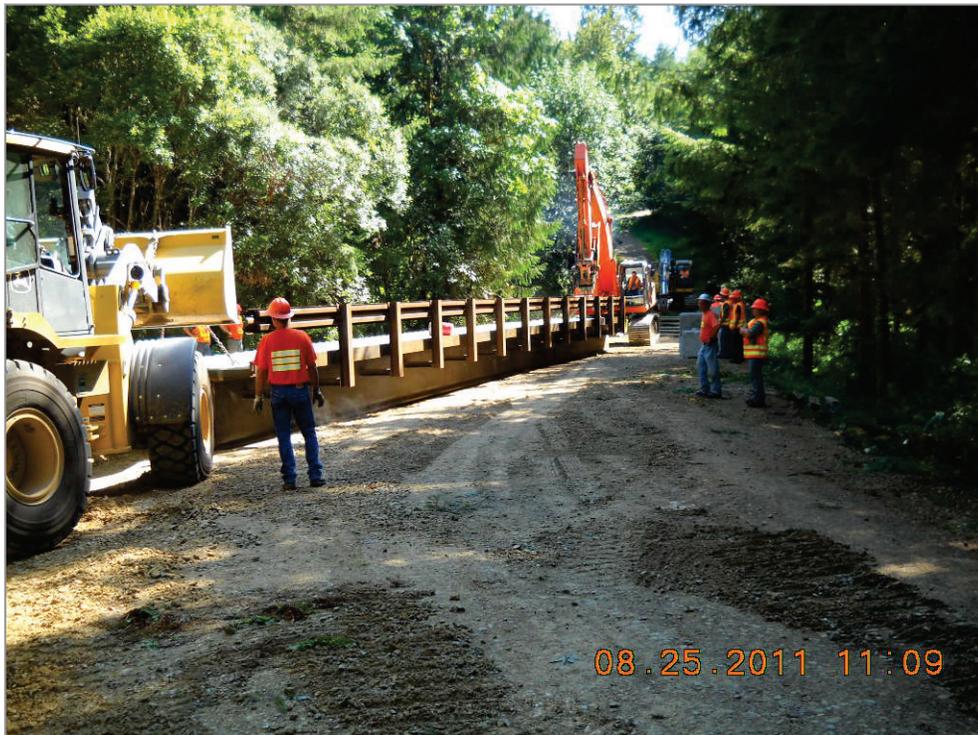
Photo 10: County crews lifted, pushed and pulled the bridge halves into position. 08/25/2011.

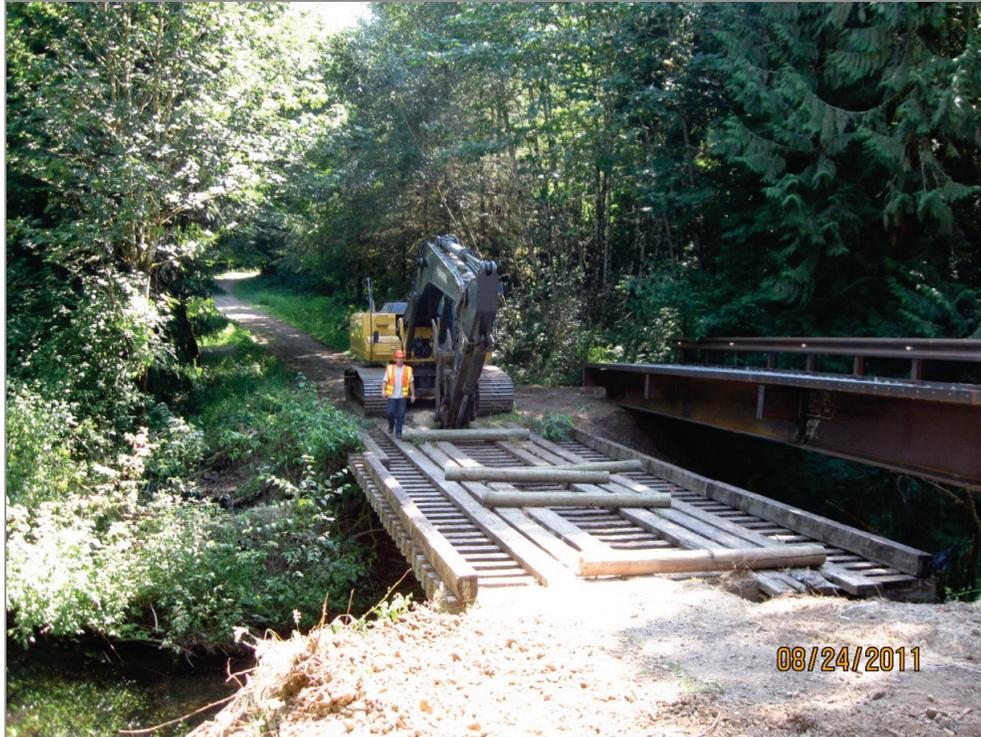
Photo 11: County crews used the old bridge to roll the leading edge of the first half across the creek. 08/24/2011.

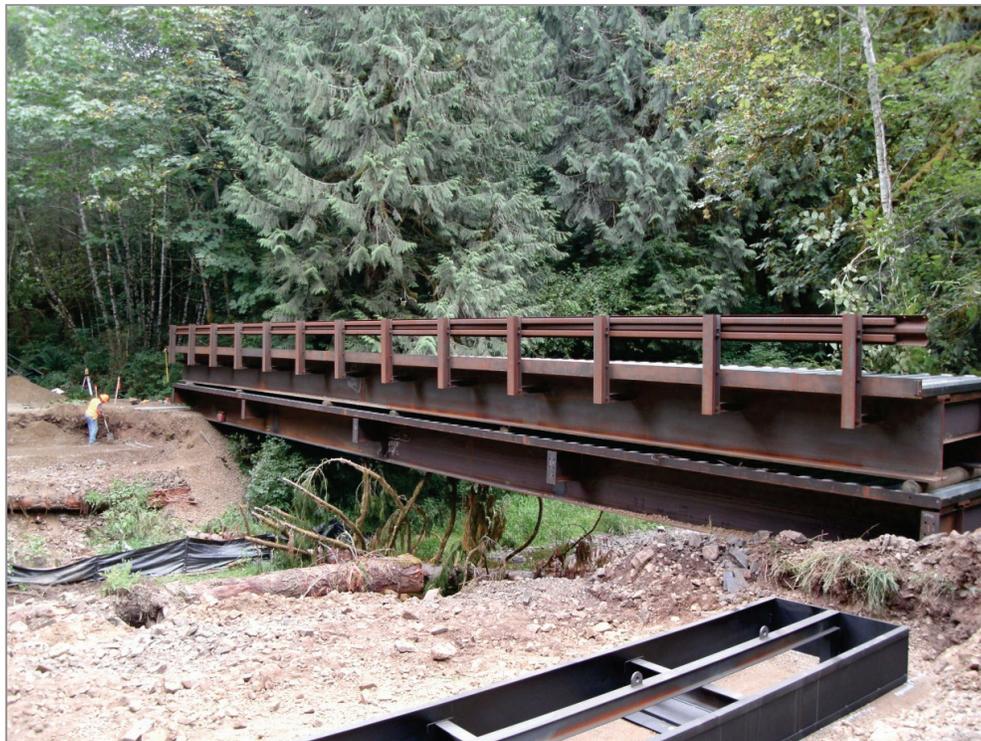
Photo 12: Abutments pads were prepared and the SuperSills poured in place. 08/29/2011.

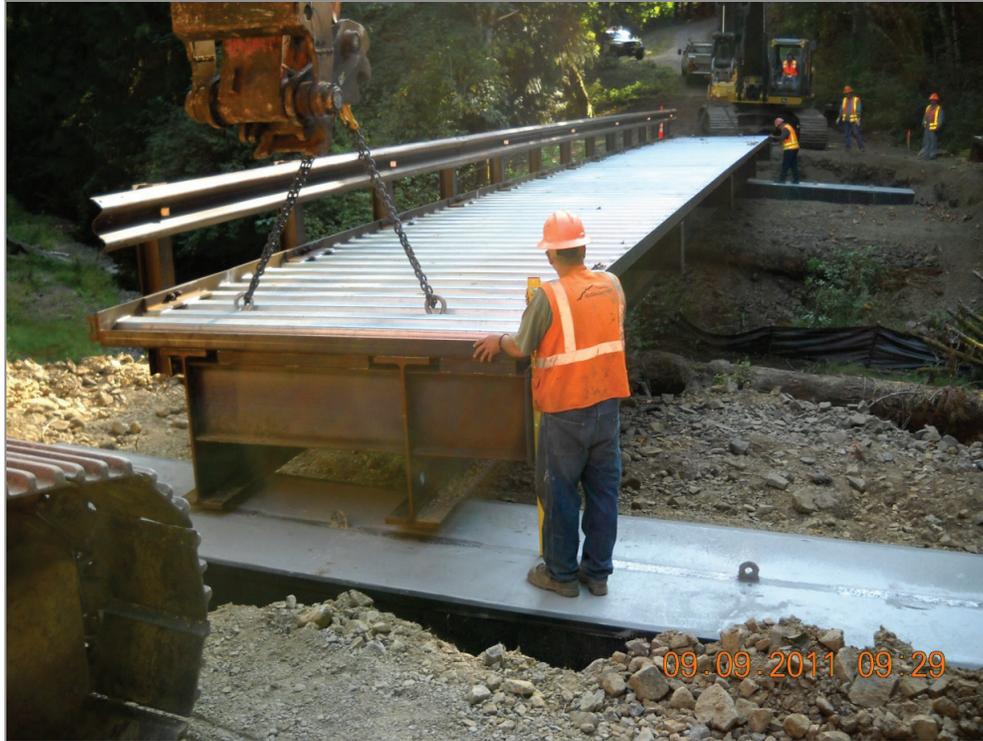
Photo 13: After SuperSills had cured, County crews used excavators to place the bridge halves. The level was used to place the bridge precisely as needed. 09/09/2011.

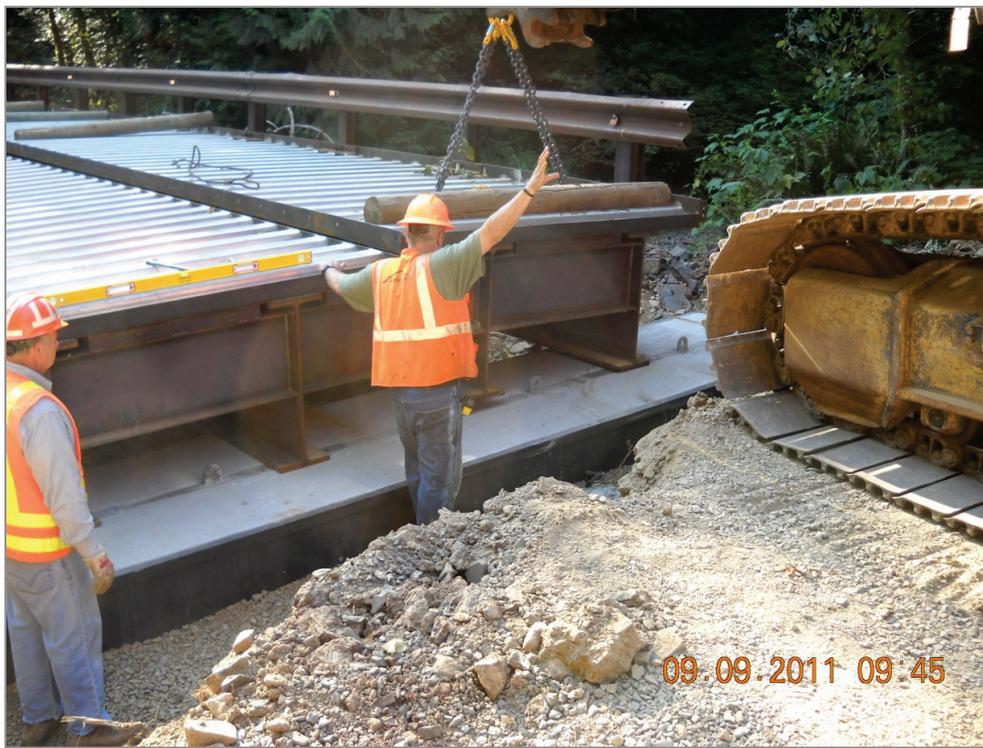
Photo 14: Bridge halves went quickly into place. 09/09/2011.

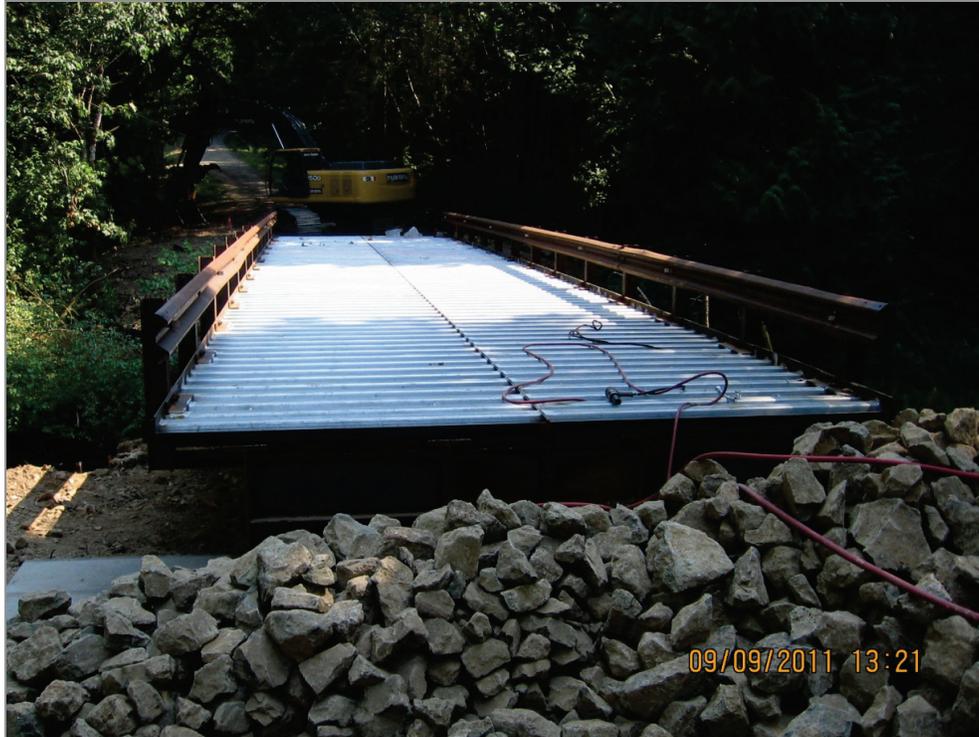
Photo 15: Approach construction and bolt tightening occurred immediately. 09/09/2011.

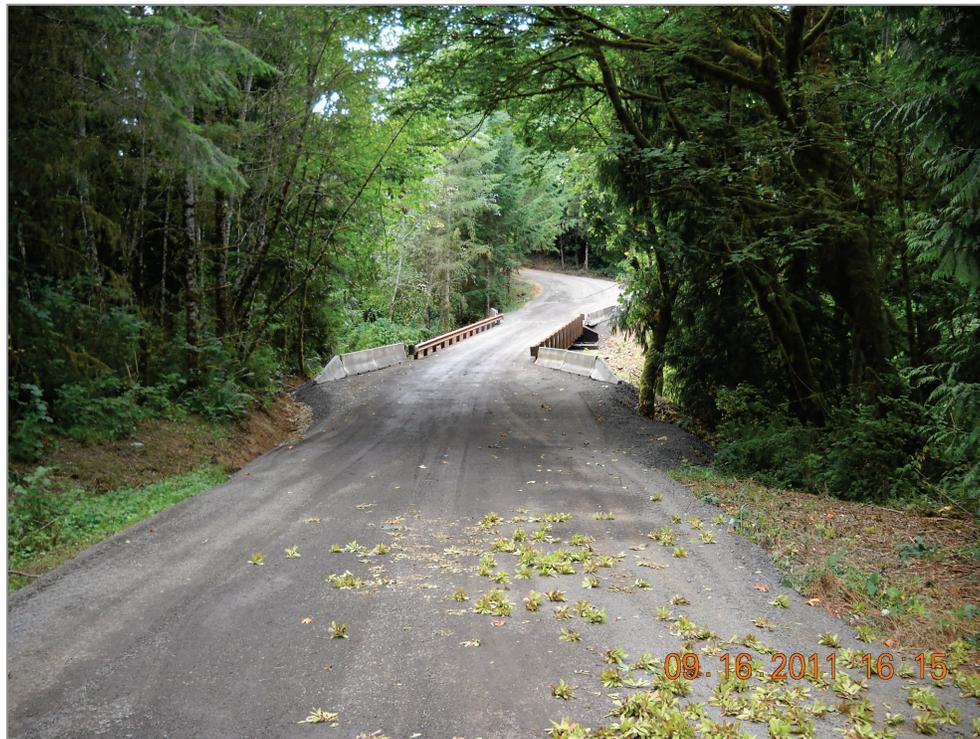
Photo 16: Project complete on 09/13/2011. 09/16/2011.
