Cowlitz County
 Department of Public Works

Kalama River Road Slide Repair

The Kalama River Road Slide Repair Project will stabilize an existing landslide by installing shear piles, improving drainage and placing new culverts.

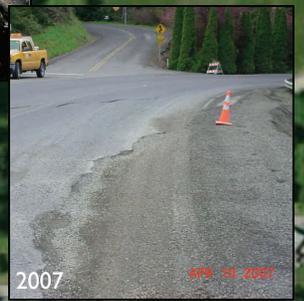
Kalama River Road Slide Repair Project Map

- Project area and new roadway alignments.
- New culvert locations.
- Piling locations.

Culverts, piling and new subgrade are designed to allow better subgrade drainage, increase slope stability and reduce future buckling and slides.
